Chapter 17

High-Temperature and Low-Temperature Fatigue

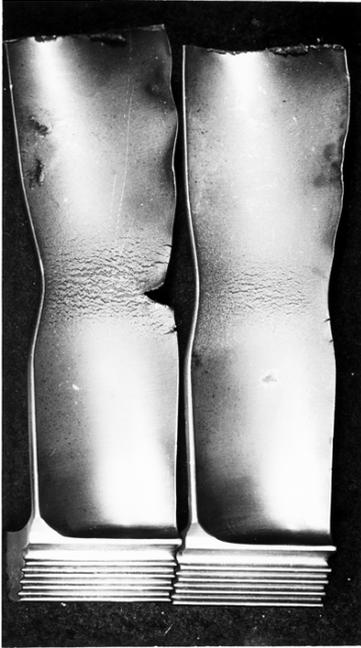
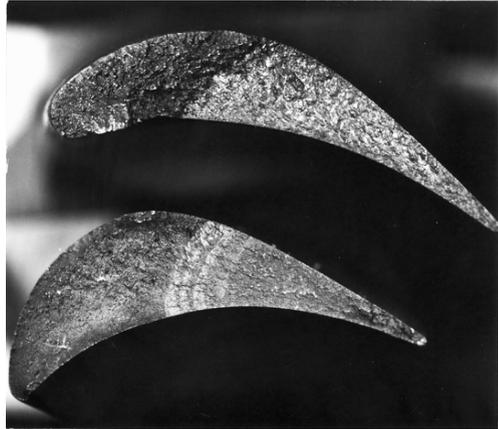
Fig. 17.1 Turbine blade failures.

(a) Turbine blades with large creep deformation and cracking due to overheating. Blade length 11 cm

(b) Fatigue failures in turbine blades starting at the trailing edge (blade chord 25 mm)

The blades are cyclically exposed to high centrifugal forces with one cycle corresponding to a single engine run-up and shutdown, which is a low-cycle fatigue condition. Because of the sustained centrifugal force and high working temperature, creep may occur. This obviously occurred to the turbine blade in Figure 17.1a. Furthermore, blade vibrations at a high frequency induce high-cycle fatigue conditions. Fatigue fractures due to these vibratory loading are shown in Figure 17.1b. A third type of load is coming from thermal stresses. During engine run-up, the blade temperature is increased very rapidly which leads to a transient inhomogeneous temperature distribution in the blade. The temperature of the thin trailing edge of the blade is increased much faster than in the bulk of the blade. This also applies to the leading edge, although to a lesser extent. During engine shutdown the cooling of the trailing and leading edge will be faster. The inhomogeneous temperature in the blade and the related thermal expansion and contraction are causing a thermal stress cycle. It has resulted in a fatigue crack in the trailing edge of the turbine blade shown in Figure 17.2 (low-cycle fatigue). Crack growth occurred along the grain boundaries. Plastic deformation in the grain boundaries is very difficult at room temperature, but at a high temperature the grain boundaries become weaker than the matrix of the grains (grain boundary sliding and cavity formation) with intergranular cracking as a result.

The material of the blades shown in Figures 17.1 and 17.2 is a nickel alloy (Nimonic) which was developed as a high-temperature material for turbine blades in view of the high working temperature. The failures shown in these figures occurred in the 1960s. However, a further increase of the working temperature was required for improving the efficiency of turbofan engines. This has led to the development of new materials which also required new blade production techniques. Transverse grain boundaries were eliminated by producing turbine blades as monocrystals with a unidirectionally solidified eutectic composition [1, 2] which greatly improved the creep resistance. The eutectic structure consists of a matrix

as one phase of the eutecticum embedding long fibers as the second phase. Obviously, the directionality of the eutectic composite should be in the length direction of the blade. This is an example of designing a material and a production process for a special application. Special coatings are also applied to turbine blades in order to resist surface oxidation. Furthermore, new blade cooling systems have been introduced. As a consequence, turbine blades are highly complex and expensive [3]. The major problem is not designing against fatigue, but developing materials and blades for extremely high-temperature application. Of course, stress distributions in the blade and the joint between the blades and the turbine disk must still be considered in view of fatigue (see the wiffle tree in Figure 17.1a).

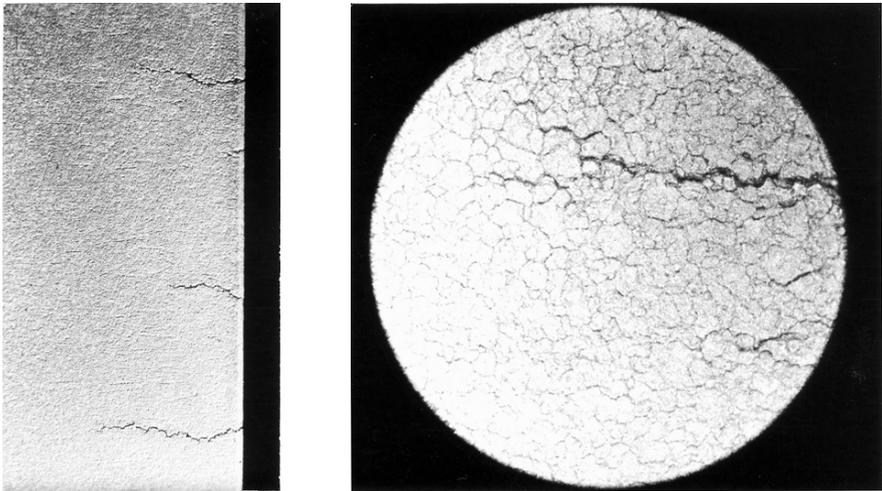
Fig. 17.2 Intergranular fatigue crack in trailing edge of a turbine blade due to thermal fatigue.

(a) Trailing edge with cracks. Length of lower crack 4 mm

(b) Intergranular character of crack. Diameter of optical field 2.5 mm

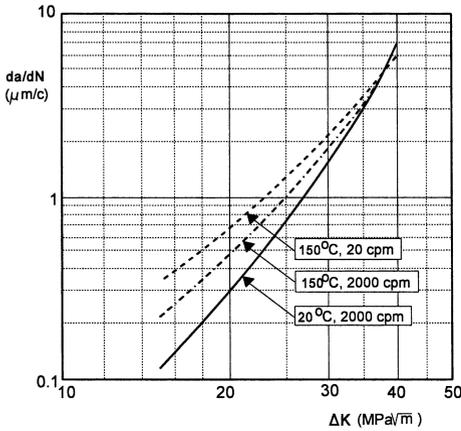
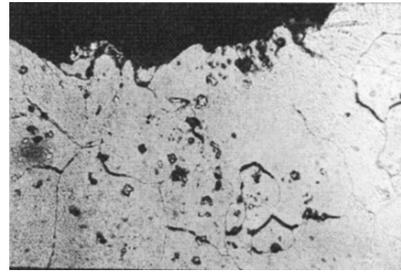
Fig. 17.4 Fatigue and creep crack growth in an Al-alloy (2024-T3) [8].

(a) The effect of the temperature and frequency on the fatigue crack growth rate

(b) Intergranular crack growth and grain boundary voids during creep at $S = 200$ MPa and $T = 150^\circ\text{C}$ (width of picture 200 μm).

Most basic material data on the temperature effect were obtained as low-cycle fatigue results of tests on unnotched specimens. Such tests can indicate a safe upper temperature limit which precludes creep deformation, in most cases a criterion to be satisfied. Fatigue crack growth at an elevated but still acceptable temperature is then of interest. Fatigue crack growth data for elevated temperatures were essential for the development of the Concorde. Some results of an old elementary test program on an aluminium alloy are presented in Figure 17.4. Tests were carried out on center cracked specimens at room temperature and 150°C . For the elevated temperature tests, frequencies of 2000 and 20 cycles per minute were used. Crack growth was faster at the elevated temperature, and at this temperature, it was again faster for the lower frequency. Crack growth under all three conditions was still transgranular. Tests at 150°C on precracked specimens ($a_0 = 12$ mm) were also carried out under sustained load. Crack growth by creep until $a = 20$ mm occurred in 32 hours, while crack growth now was intergranular and grain boundary voids were also observed in the wake of the crack, see the illustration in Figure 17.4b. The difference between the fracture mechanisms of fatigue and creep is confirmed.
